INDOOR AIR QUALITY ASSESSMENT

**Malden High School
B-Building
77 Salem Street
Malden, Massachusetts**

Prepared by:
Massachusetts Department of Public Health
Center for Environmental Health
Emergency Response/Indoor Air Quality Program
September 2006

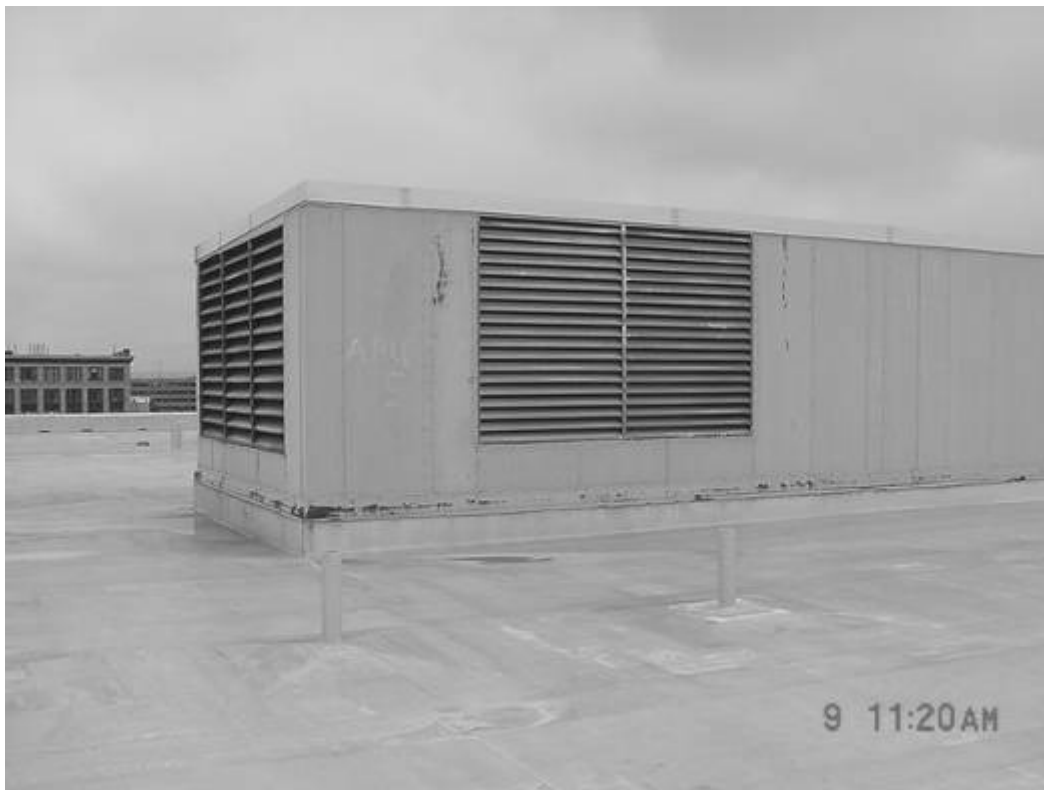
Picture 1

Mechanical ventilation is provided by three-large rooftop air-handling units (AHUs) equipped with high efficiency pleated air filters (Pictures 1 and 2). Fresh air is continuously distributed via ceiling-mounted air diffusers and ducted back to AHUs via ceiling-mounted return vents (Pictures 3 and 4). These systems were operating during the assessment. Mr. Lessard reported that fresh air intake was set at 100 percent at the time of the assessment (Picture 2).

One of Three Rooftop AHUs for B-Building

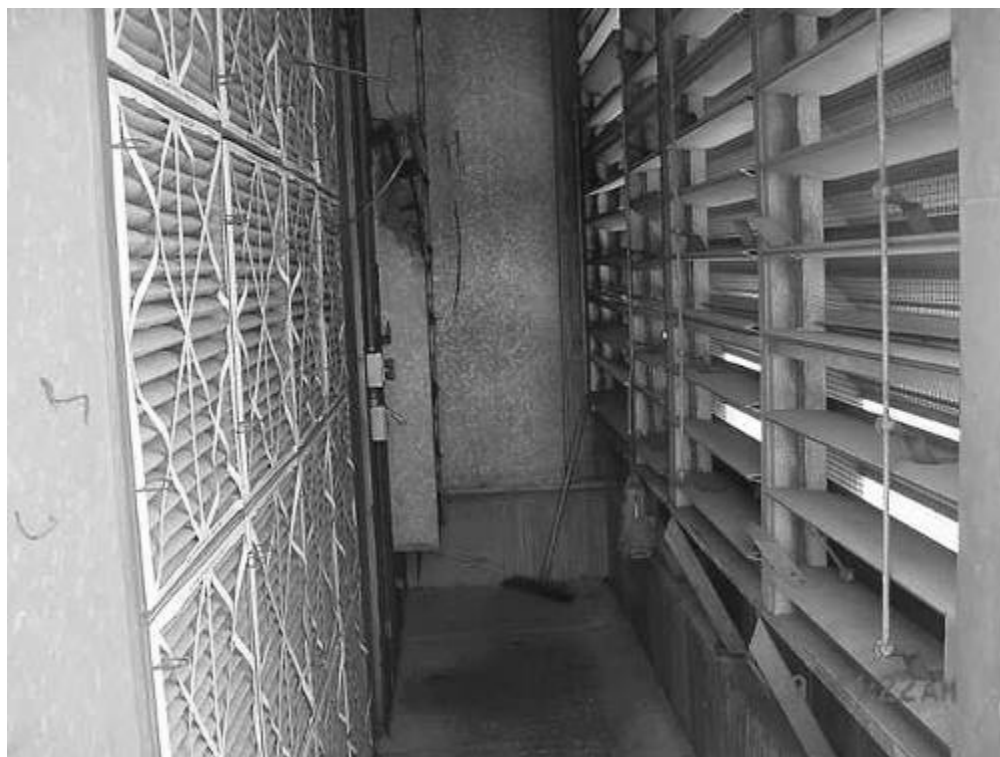
Picture 2

Fresh Air Intake Louvers Fully Opened (100%) and Pleated Air Filters

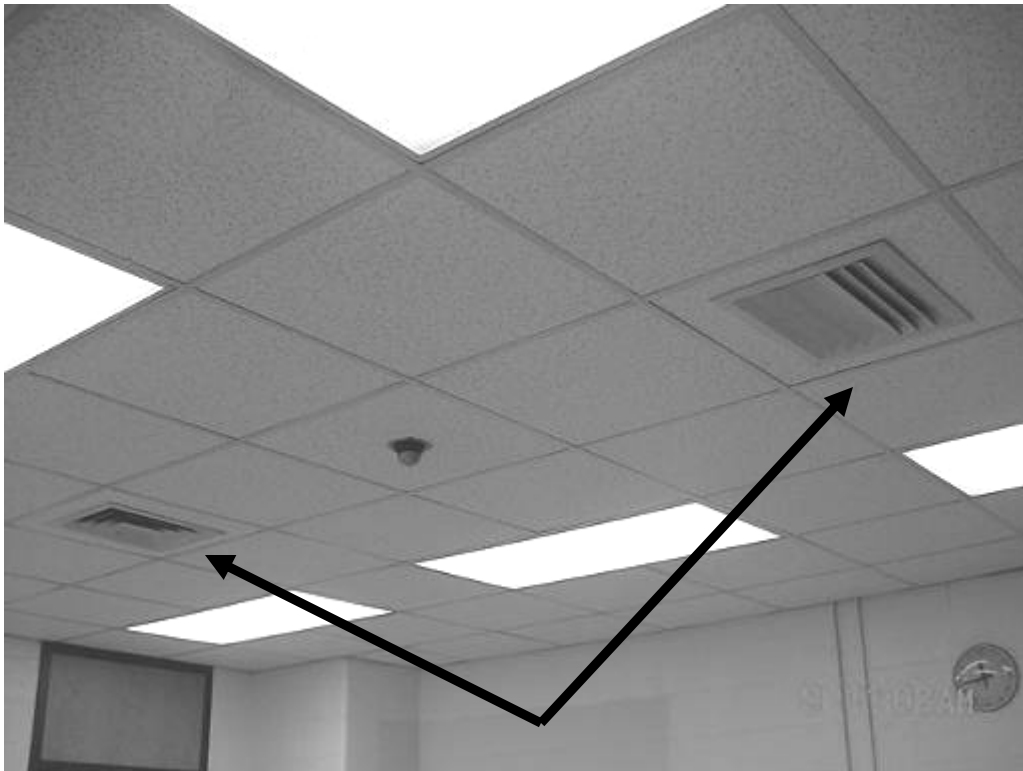
Picture 3

Ceiling-Mounted Supply and Return Vents

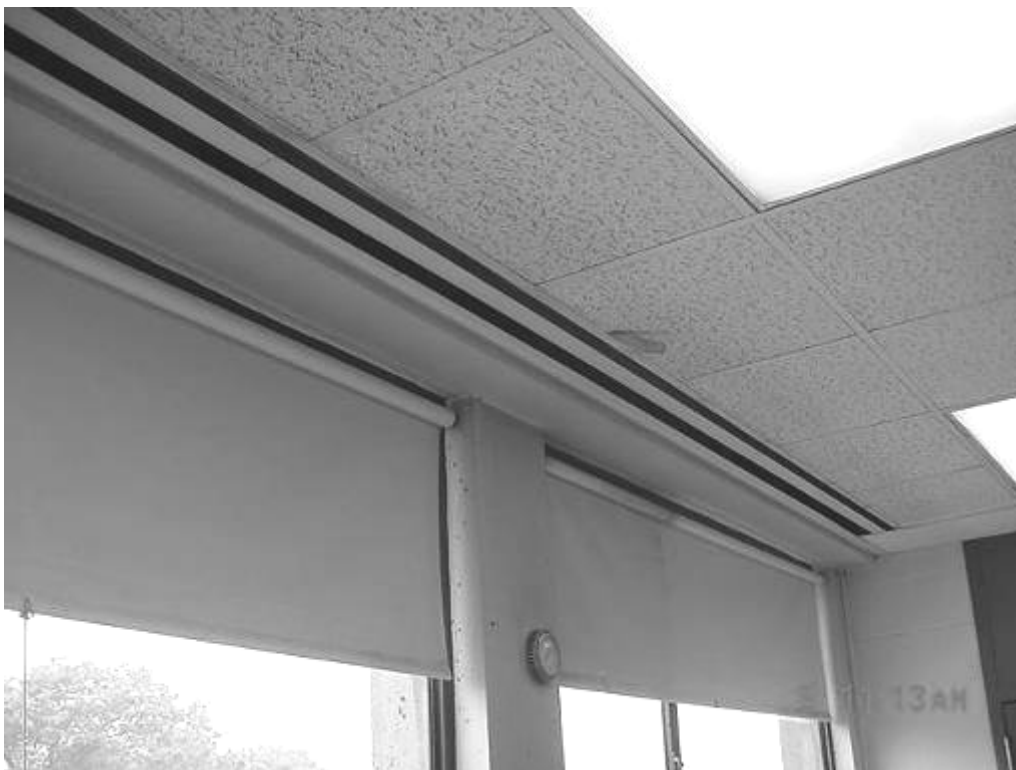
Picture 4

Slotted Air Diffuser along Perimeter

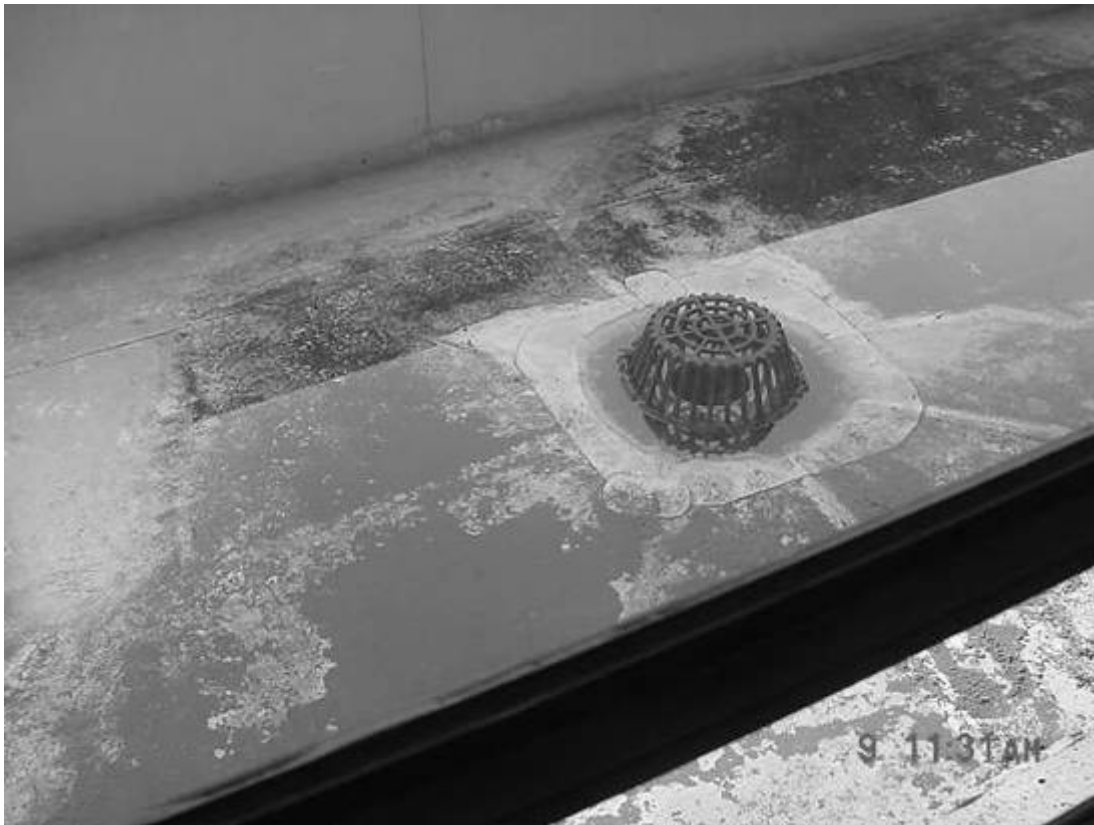
Picture 5

As previously mentioned, due to exacerbation of allergies and mold concerns, CEH staff conducted a thorough visual examination of the guidance suite. No water damage, visible mold growth and/or associated odors were observed in this area. However, what appeared to be plant debris and pooling water was observed on the roof directly outside the guidance suite (room B-207), (Picture 5) at the time of the assessment. Pooling water and saturated plant debris can provide a potential medium for mold growth and associated odors. Given that it was outside the window and not near any fresh air intakes for the mechanical ventilation system, direct exposure is not a concern. However it is recommended that the area be cleaned and disinfected.

Black, Mold-Like Debris Accumulated around Roof Drain outside Guidance Office B-207

1. Clean accumulated debris periodically from around roof drain outside of guidance room B-207 to remove/prevent mold growth and associated odors.
2. For buildings in New England, periods of low relative humidity during the winter are often unavoidable. Therefore, scrupulous cleaning practices should be adopted to minimize common indoor air contaminants whose irritant effects can be enhanced when the relative humidity is low. To control for dusts, a high efficiency particulate arrestance (HEPA) filter equipped vacuum cleaner in conjunction with wet wiping of all surfaces is recommended. Avoid the use of feather dusters. Drinking water during the day can help ease some symptoms associated with a dry environment (throat and sinus irritations).

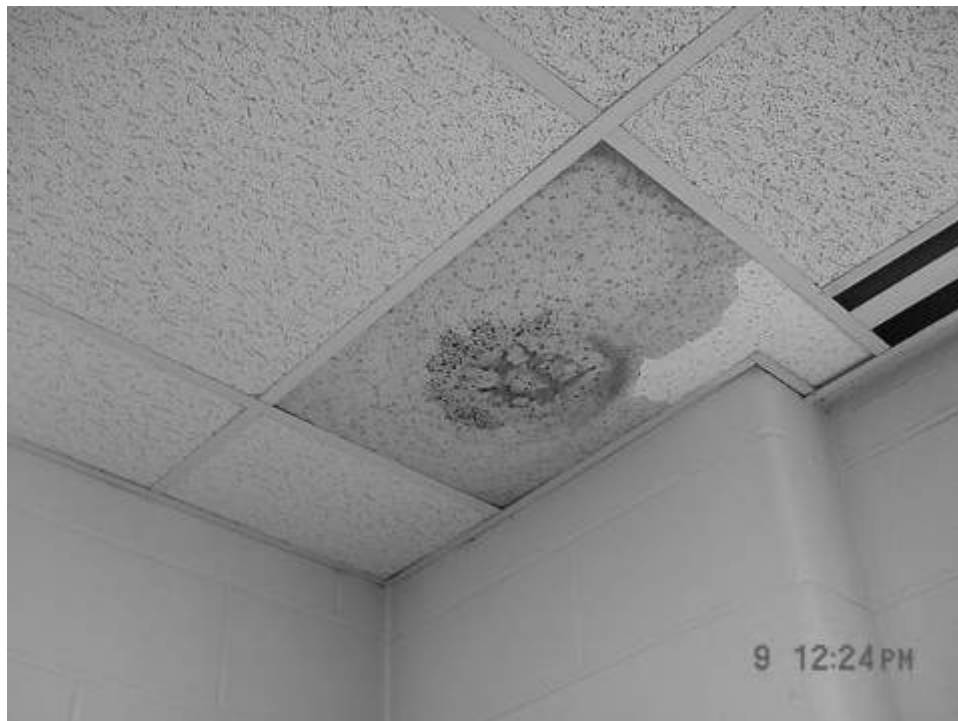
Picture 6

Active roof leaks in other areas of B-building were observed, specifically classroom 420 (Picture 6) and in the 4th floor hallway outside of B-418, where water was dripping and pooling on floor tiles (Picture 7). Water-damaged ceiling tiles can provide a source of mold and should be replaced after a water leak is discovered and repaired. A historic plumbing leak was reported in classroom B-424. CEH staff removed ceiling tiles (Picture 8) to inspect the ceiling plenum. No current water damage, visible mold or associated odors were detected, however, the plumbing fixture which appeared to be the past source of water damage was severely corroded (Picture 8).

Water Damaged Ceiling Tile in Classroom B-420, Indicating Current Leak

3. Ensure roof/plumbing leaks are repaired and replace water damaged ceiling tiles. Examine the area above and around these areas for mold growth. Disinfect areas of water leaks with an appropriate antimicrobial.

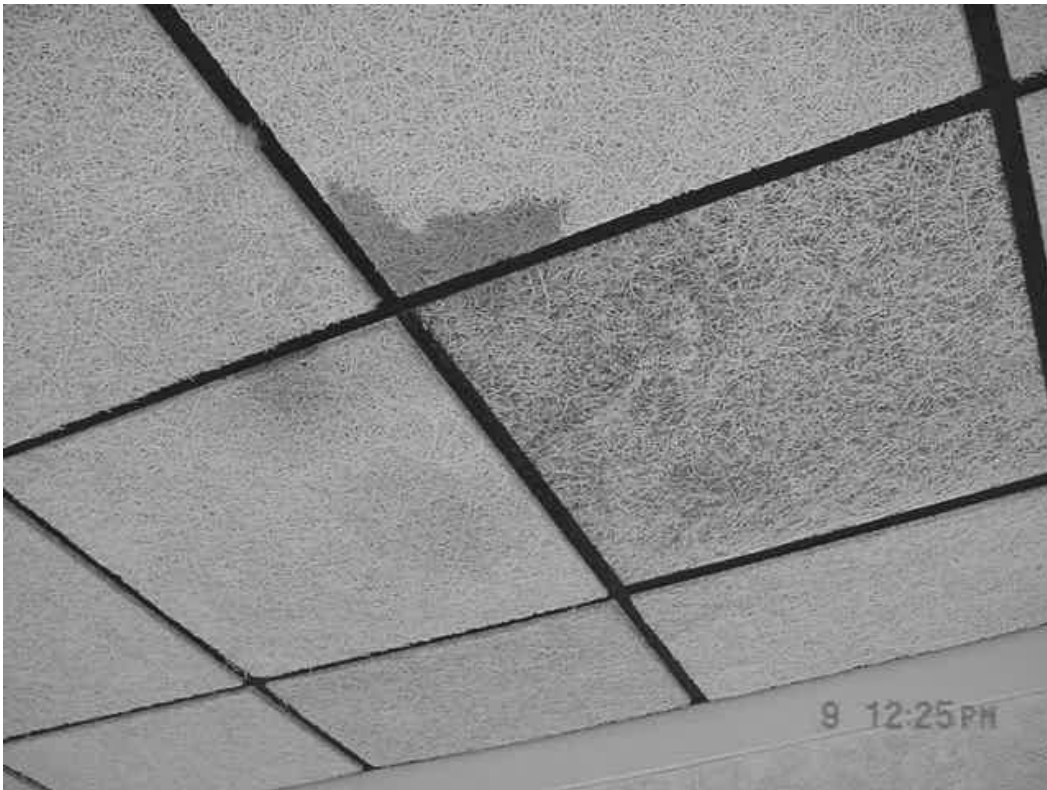
Picture 7

Water Damaged Ceiling Tile in 4th Floor Hallway outside Classroom B-418, Indicating Current Leak

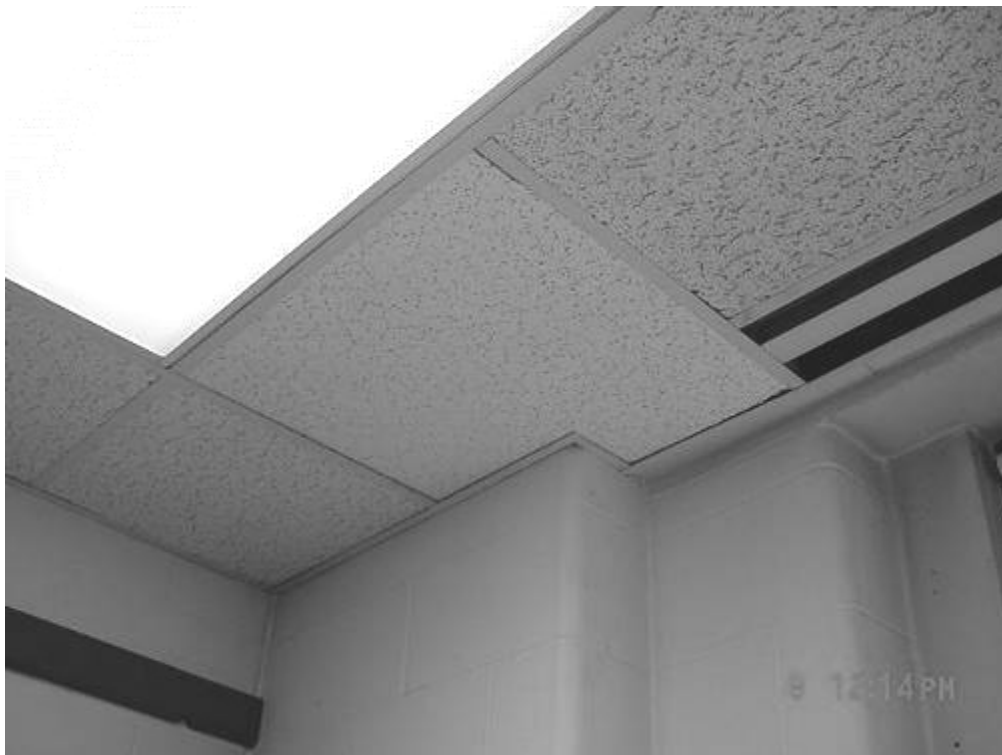
Picture 8

Area of Historic Water Damage in Classroom B-424, Note New(er) Ceiling Tile

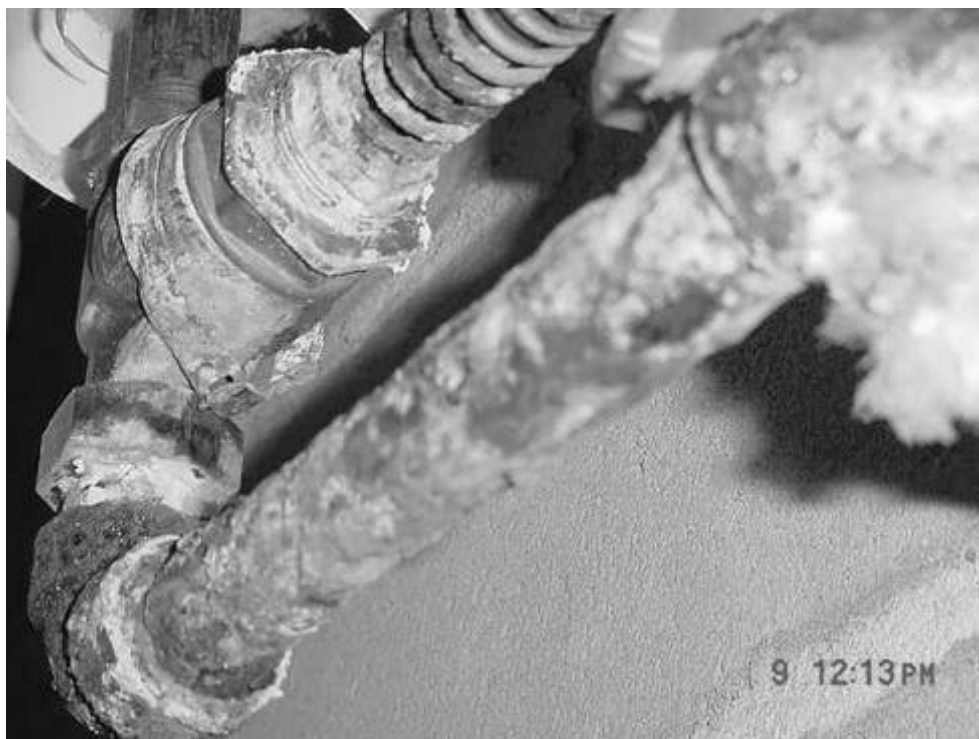
Picture 9

Severely Corroded Pipe above Ceiling Tiles in Preceding Picture Classroom B-424

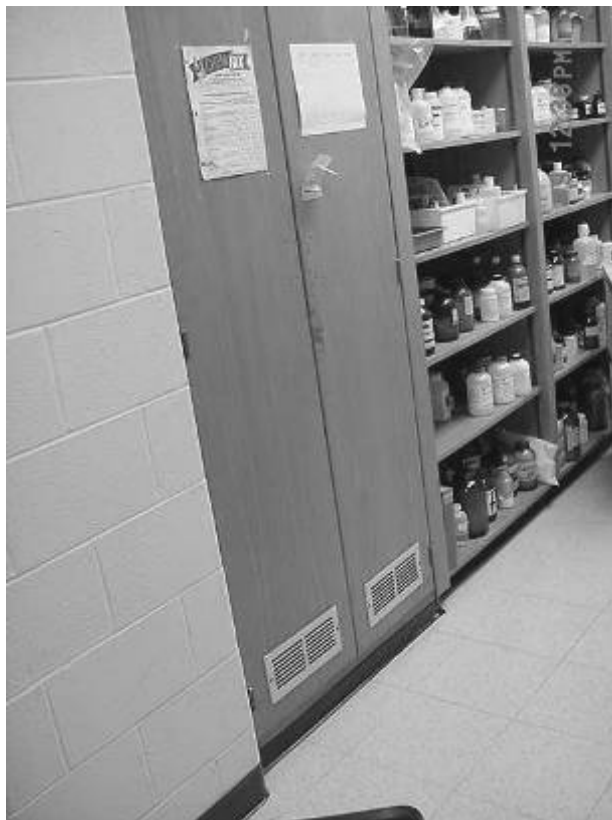
Picture 10

School officials reported that a hazardous waste disposal company was summoned to go through the chemicals present in the laboratories and remove unwanted or unused materials prior to the 2005-2006 school year. CEH staff examined conditions in the B-420 prep room. An irritating chemical odor was detected (Picture 10) upon opening a tall wooden chemical storage cabinet. Several damaged containers were observed (Picture 11) as well as bottles which had crystallized materials on the outside of the containers indicating leakage (Picture 12). The top of the cabinet had a hole (Picture 13), presumably an exhaust vent to remove odors to the outside of the building. However, during the assessment the vent was actually backdrafting *into* the cabinet, which can force off-gassing chemicals/odors into the prep room and adjacent areas. The National Fire Protection Agency (NFPA) does not require venting in flammable storage cabinets. However, it is recommended that if a flammables storage cabinet is connected to a vent system, the vent system should not be constructed in a manner to provide an oxygen source to the interior of the cabinet and it must be vented directly outdoors and not in a manner which might compromise the specific performance of the cabinet (NFPA, 1996). There did not appear to be a mechanical exhaust fan in the ductwork nor a damper of any sort to prevent backdrafting into the cabinet. This was evidenced by the presence of corrosion on the metal louvers of the ceiling-mounted air diffuser directly outside the cabinet (Picture 14).

Wooden Chemical Storage Cabinet in Prep-Room B-420

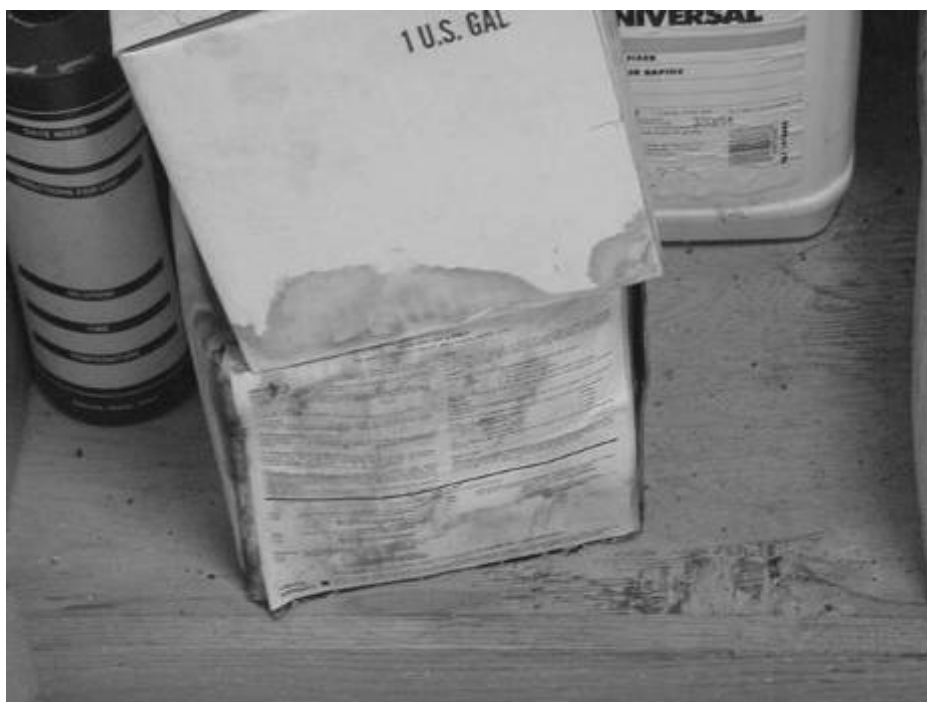
Picture 11

Damaged/Stained Containers at Bottom of Wooden Chemical Storage Cabinet in Prep Room B-420

5. Continue to do a chemical inventory in the school. Properly store flammable materials in a manner consistent with the local fire code. Discard old hazardous

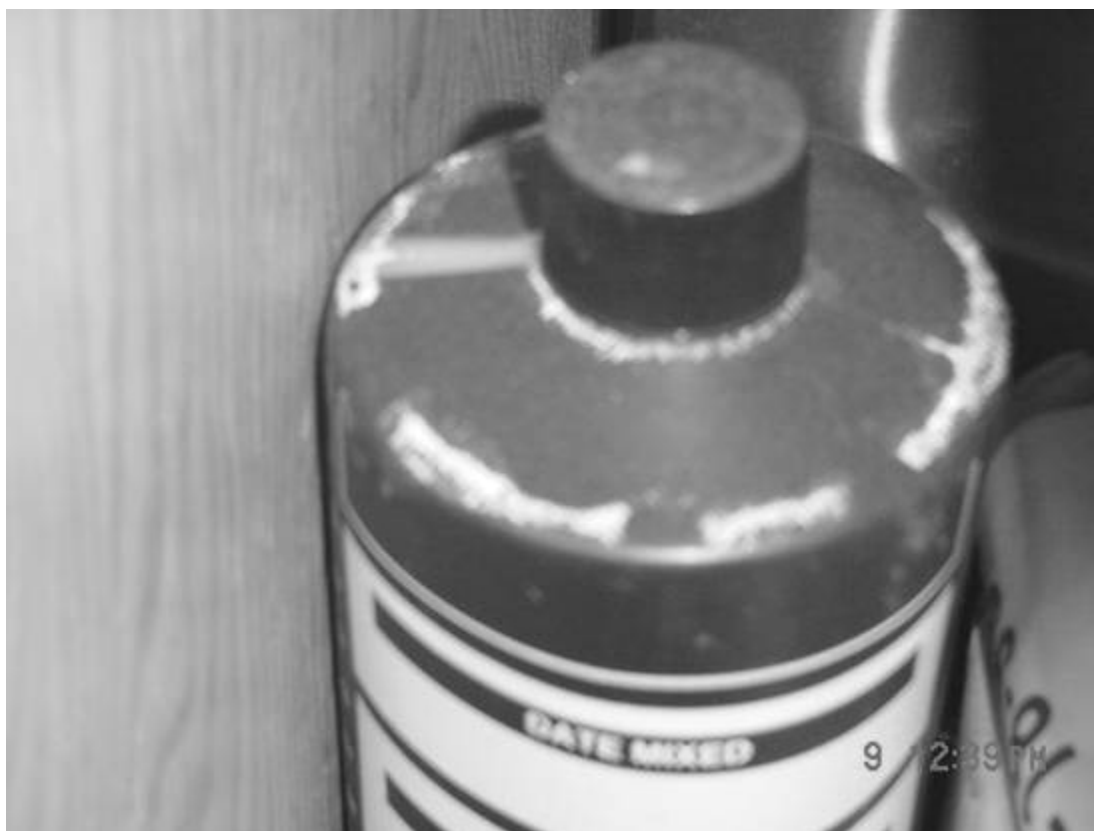
Picture 12

Crystallized Material on Container in Wooden Chemical Storage Cabinet in Prep Room B-420

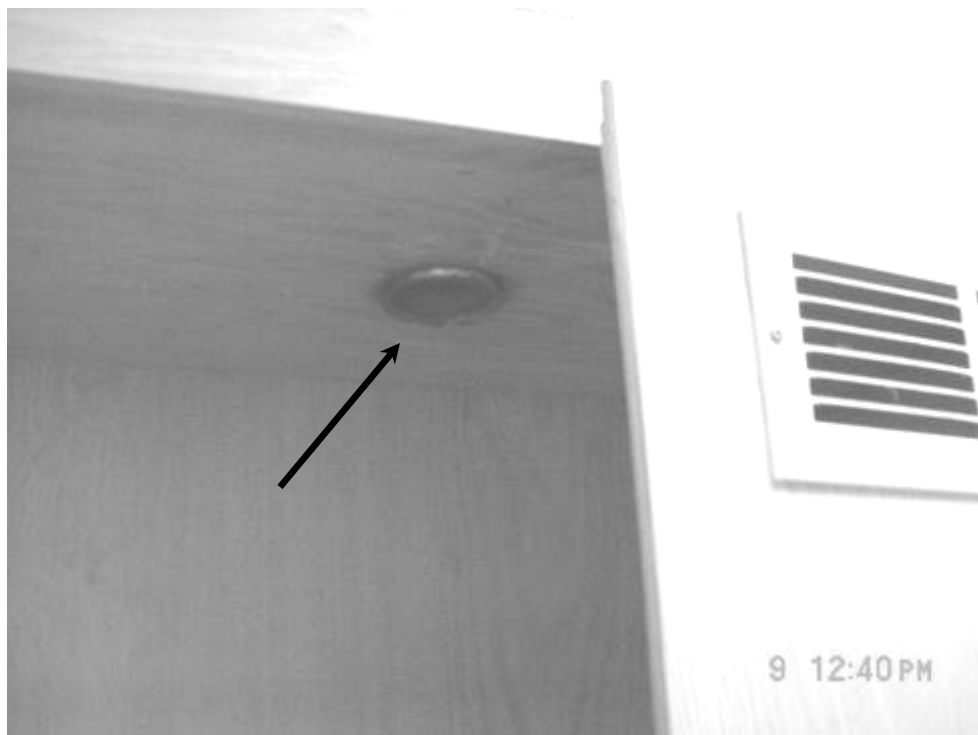
Picture 13

Opening to Ductwork in Top of Chemical Storage Cabinet, Prep Room B-420

4. Consider restoring local exhaust ventilation for chemical storage cabinet. If not feasible consider removing ductwork from flammable cabinet and sealing hole to render cabinet airtight.

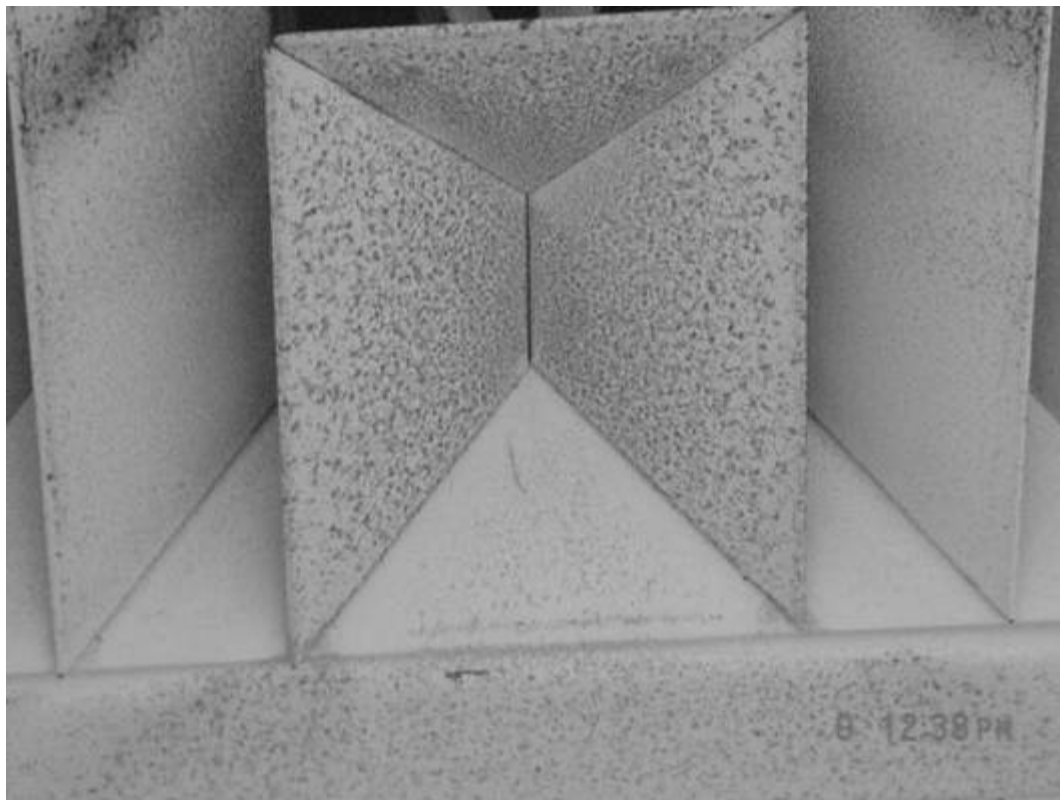
Picture 14

Corrosion on Surface of Metal Air Diffuser outside of Chemical Storage Cabinet, Prep Room B-420

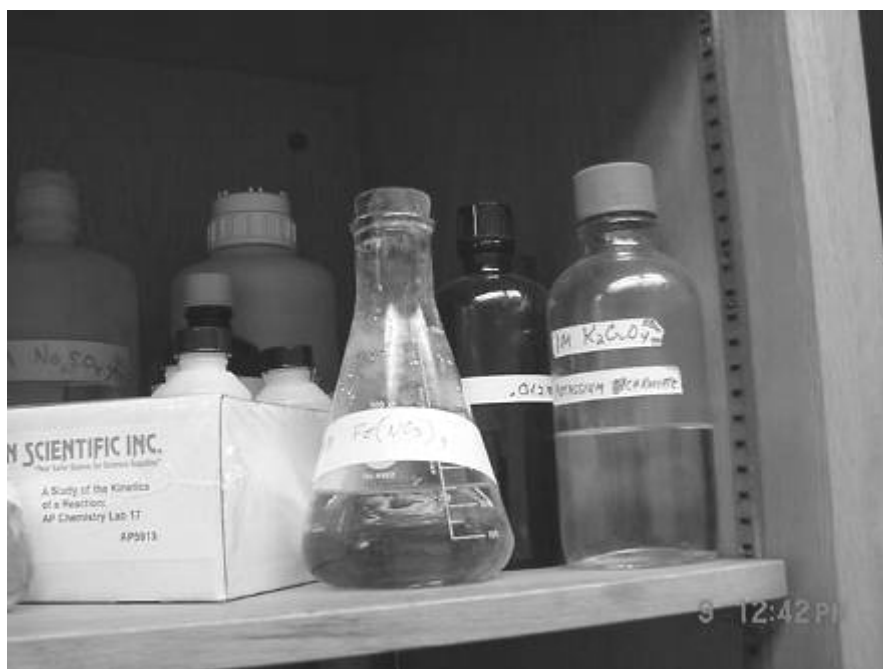
Picture 15

- Materials were labeled with chemical formula instead of chemical name (Picture 15);
- Flasks sealed with rubber stoppers (Picture 15);
- No lip on the edges of storage shelves (Picture 15);
- Acids stored beneath the sink instead of an acid storage cabinet (Picture 16).

Flask with Rubber Stopper Labeled with Chemical Formula

6. Label chemical containers with the chemical name of its contents.
7. Remove acids from below sink. Obtain and store in an acid storage cabinet.
8. Relocate or consider reducing the amount of materials stored in offices and classrooms to allow for more thorough cleaning.

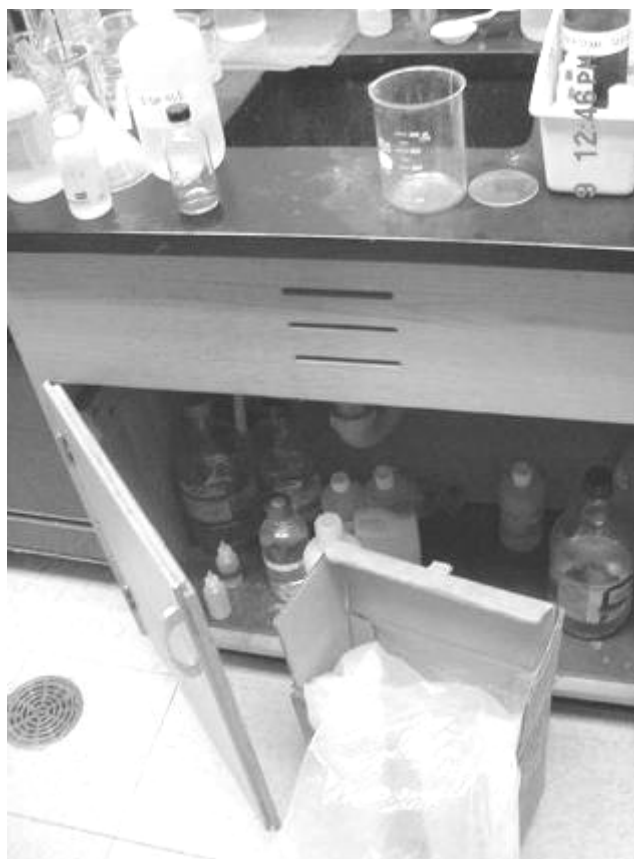
Picture 16

Acids Stored Under Sink in Prep Room B-420

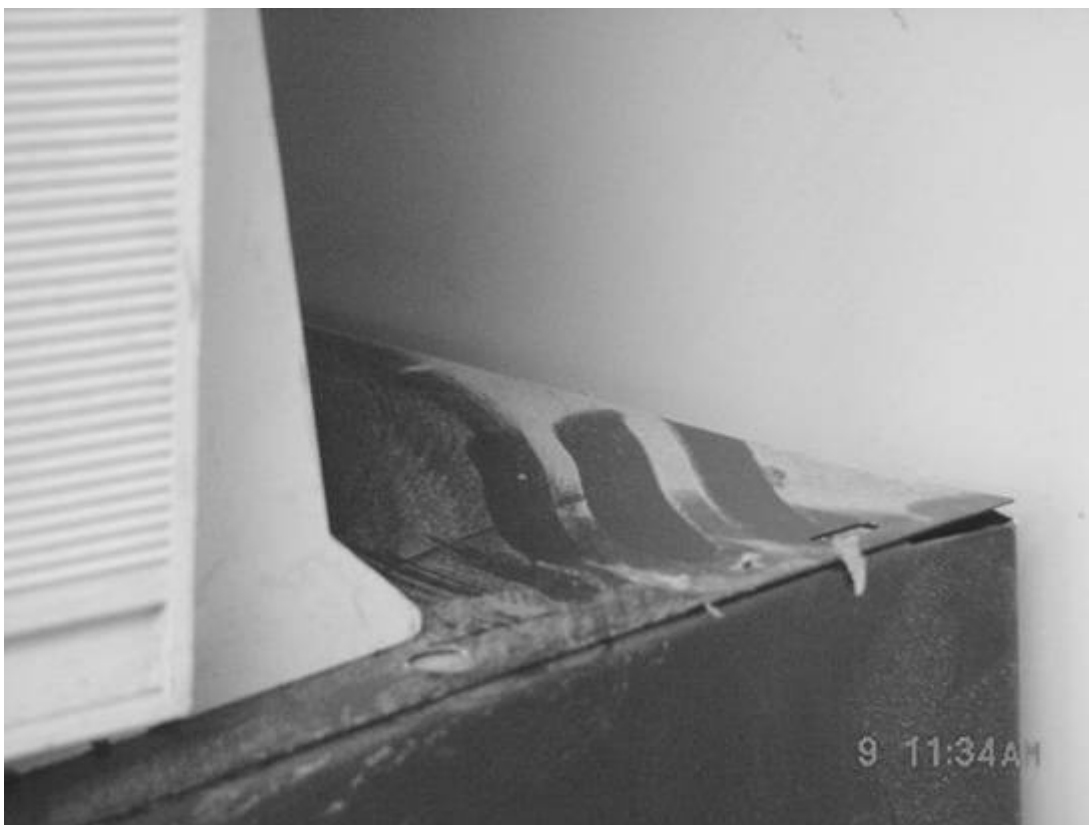
Picture 17

Several other conditions that can also affect indoor air quality were noted during the assessment. In guidance office B-207 as well as other office areas and classrooms, items were observed on windowsills, tabletops, counters, bookcases and desks. The large number of items provides a source for dusts to accumulate. These items (e.g., papers, folders, boxes) make it difficult for custodial staff to clean. Items should be relocated and/or be cleaned periodically to avoid excessive dust build up (Picture 17). Dust can be irritating to eyes, nose and respiratory tract.

Accumulated Dust on Flat Surfaces in Guidance Office B-207

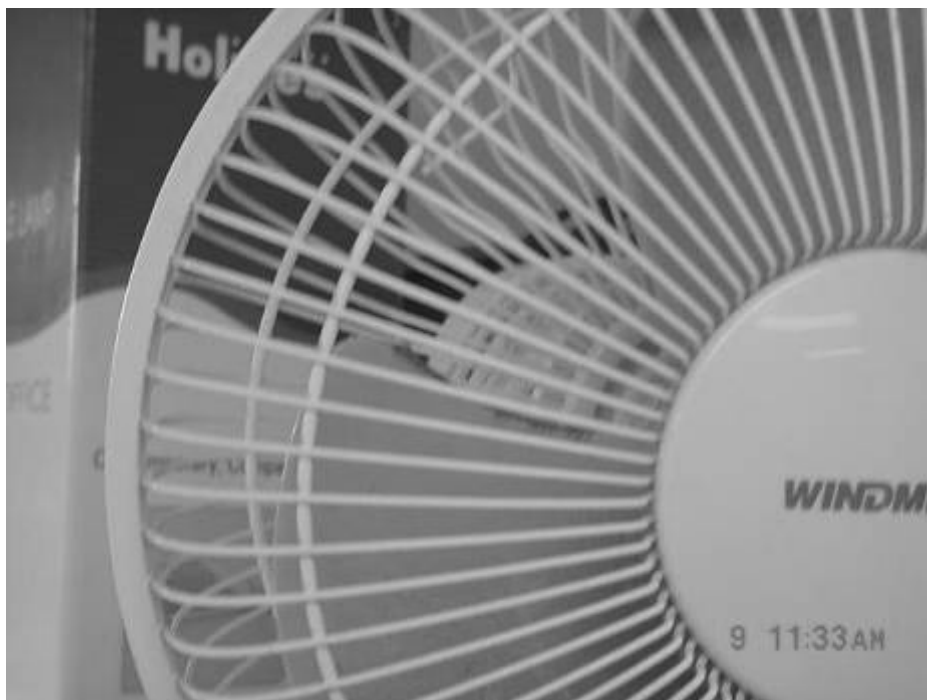
Picture 18

Portable fans, supply and return vents were observed with accumulated dust (Pictures 18 through 20). If return vents are not operating, backdrafting may occur, resulting in re-aerosolization of accumulated dust particles; supply vents and portable fans can also aerosolize dust particles when activated.

Dust Accumulation on the Blades of Portable Fan

9. Clean portable fans, supply and return vents regularly to prevent excessive dust build-up.
10. Replace missing ceiling tiles, to prevent the egress of dirt, dust and particulate matter into classrooms.

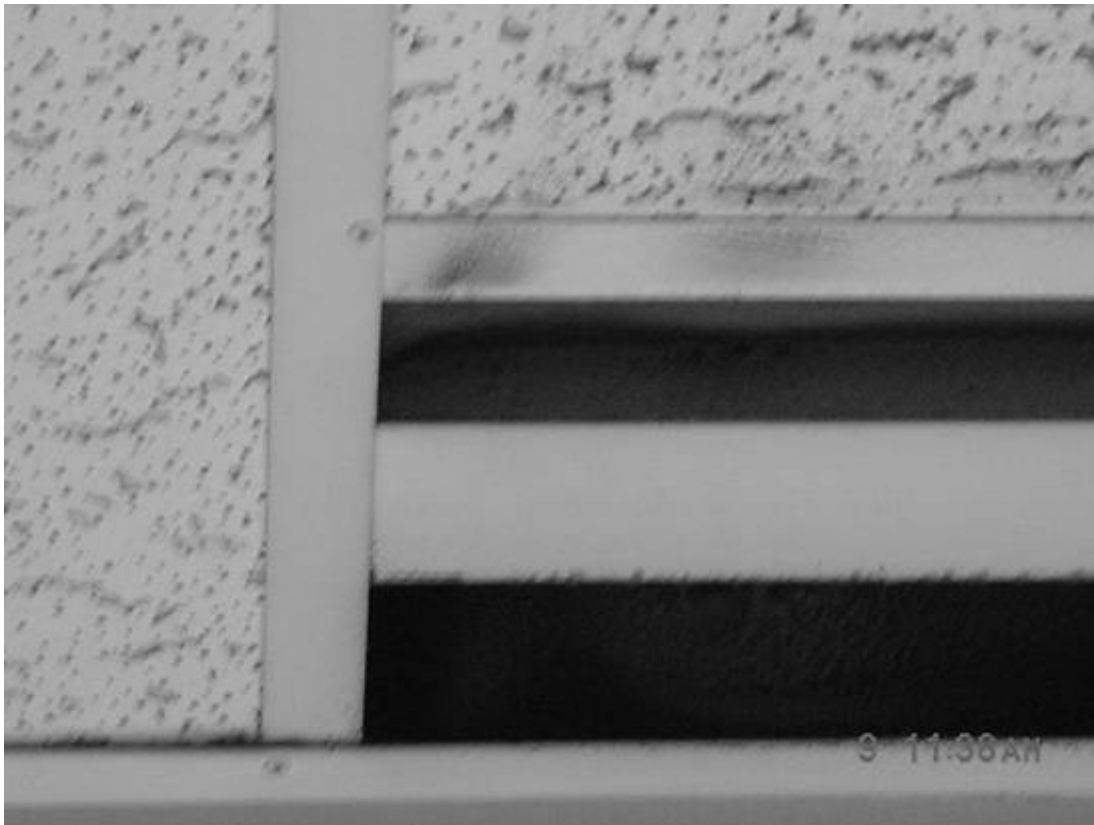
Picture 19

Dust/Debris Accumulation on Slotted Air Diffuser

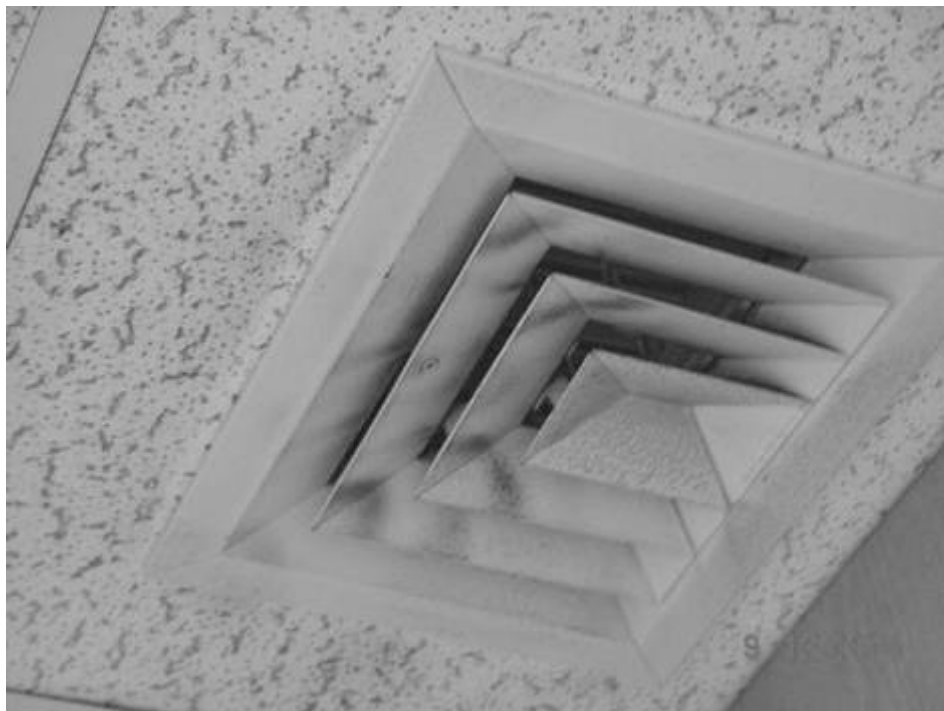
Picture 20

Dust/Debris Accumulation on Louvered Air Diffuser
